# Manhole Inspection Summary

Manhole # S41E\_\_051MH

Insp Date: **5/22/08 12:27 PM**

**Location** Address: **side 1400 lombard st**

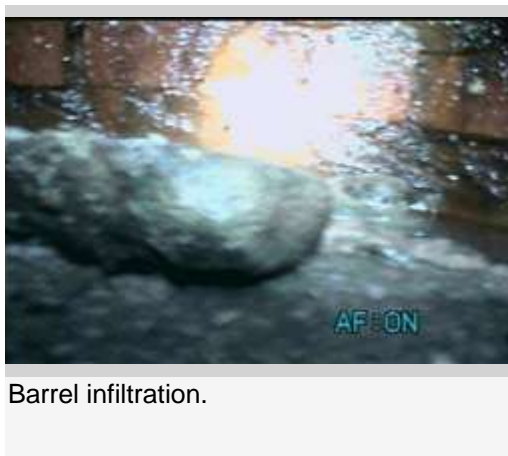
Defect 3

Infiltration: ☐ None ☐ Joint ☐ Cracks ☐ Mortar ☐ Roots ☒ **Wall**

Barrel infiltration.

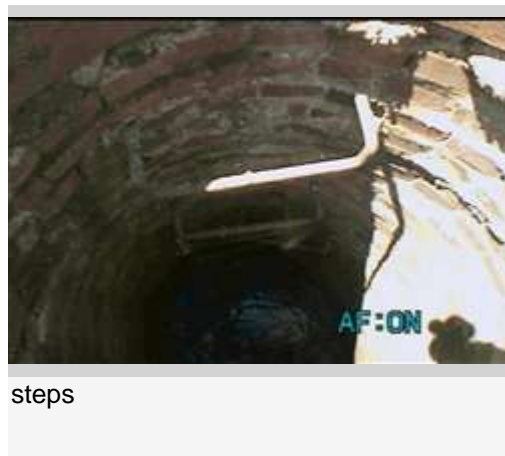
Defect 2

**Steps** Count: **9** Missing: **0** ☒ **Corroded**

steps

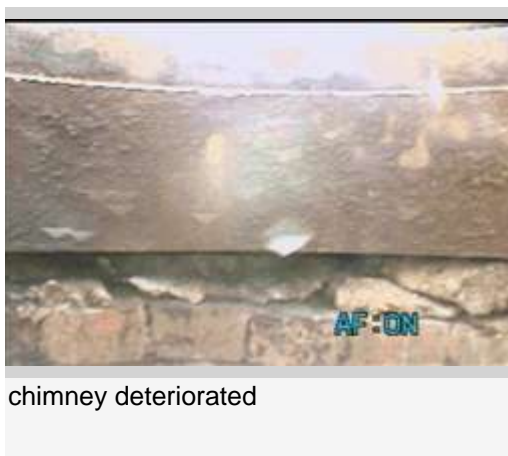
Defect 1

Condition: ☐ Sound ☐ Cracked ☐ Root Intrusion ☐ Loose Brick ☒ **Deteriorated**

chimney deteriorated

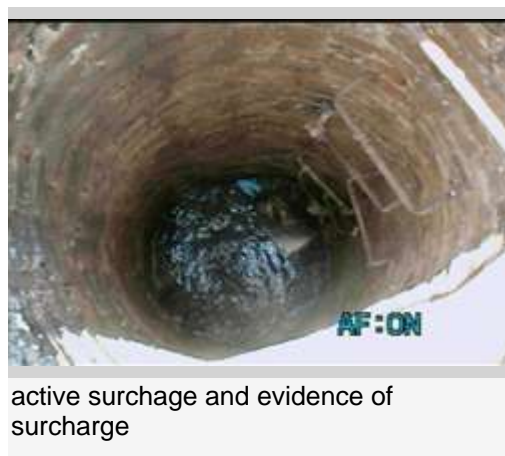
Defect 4

**Surcharge** ☒ **Evidence Of Surcharge** Depth: **8** (ft.) ☒ **Active Surcharge Present**

active surcharge and evidence of surcharge

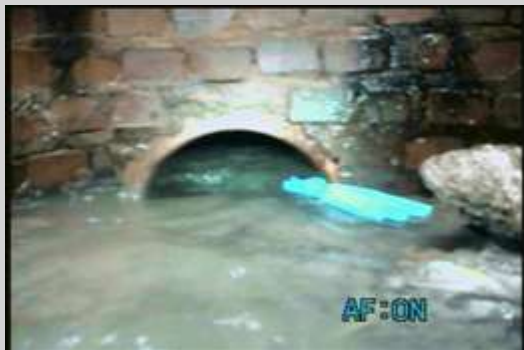
12 O'Clock Outflow

18 in. Circular Gravity Sewer  
Pipe Out @ 12 O'Clock

Invert Depth: **12.87** (ft.) Flow Characteristics: **Fast**

Infiltration: **None** Pipe Seal Cond: **Unknown**

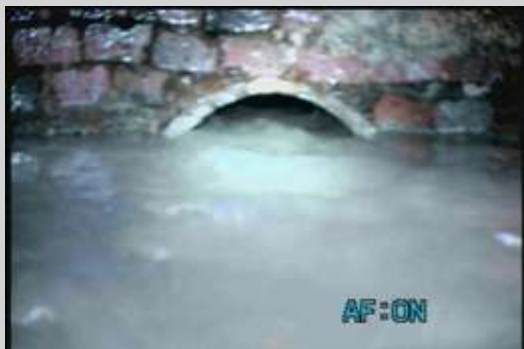
6 O'Clock Inflow

18 in. Circular Gravity Sewer  
Pipe In @ 6 O'Clock

Invert Depth: **12.70** (ft.) Flow Characteristics: **Fast**

Infiltration: **None** Pipe Seal Cond: **Unknown**
